MASTER METALS, INC.
CLEVELAND, OHIO

ENVIRONMENTAL RISK ASSESSMENT
FINAL REPORT

FEBRUARY 15, 1991

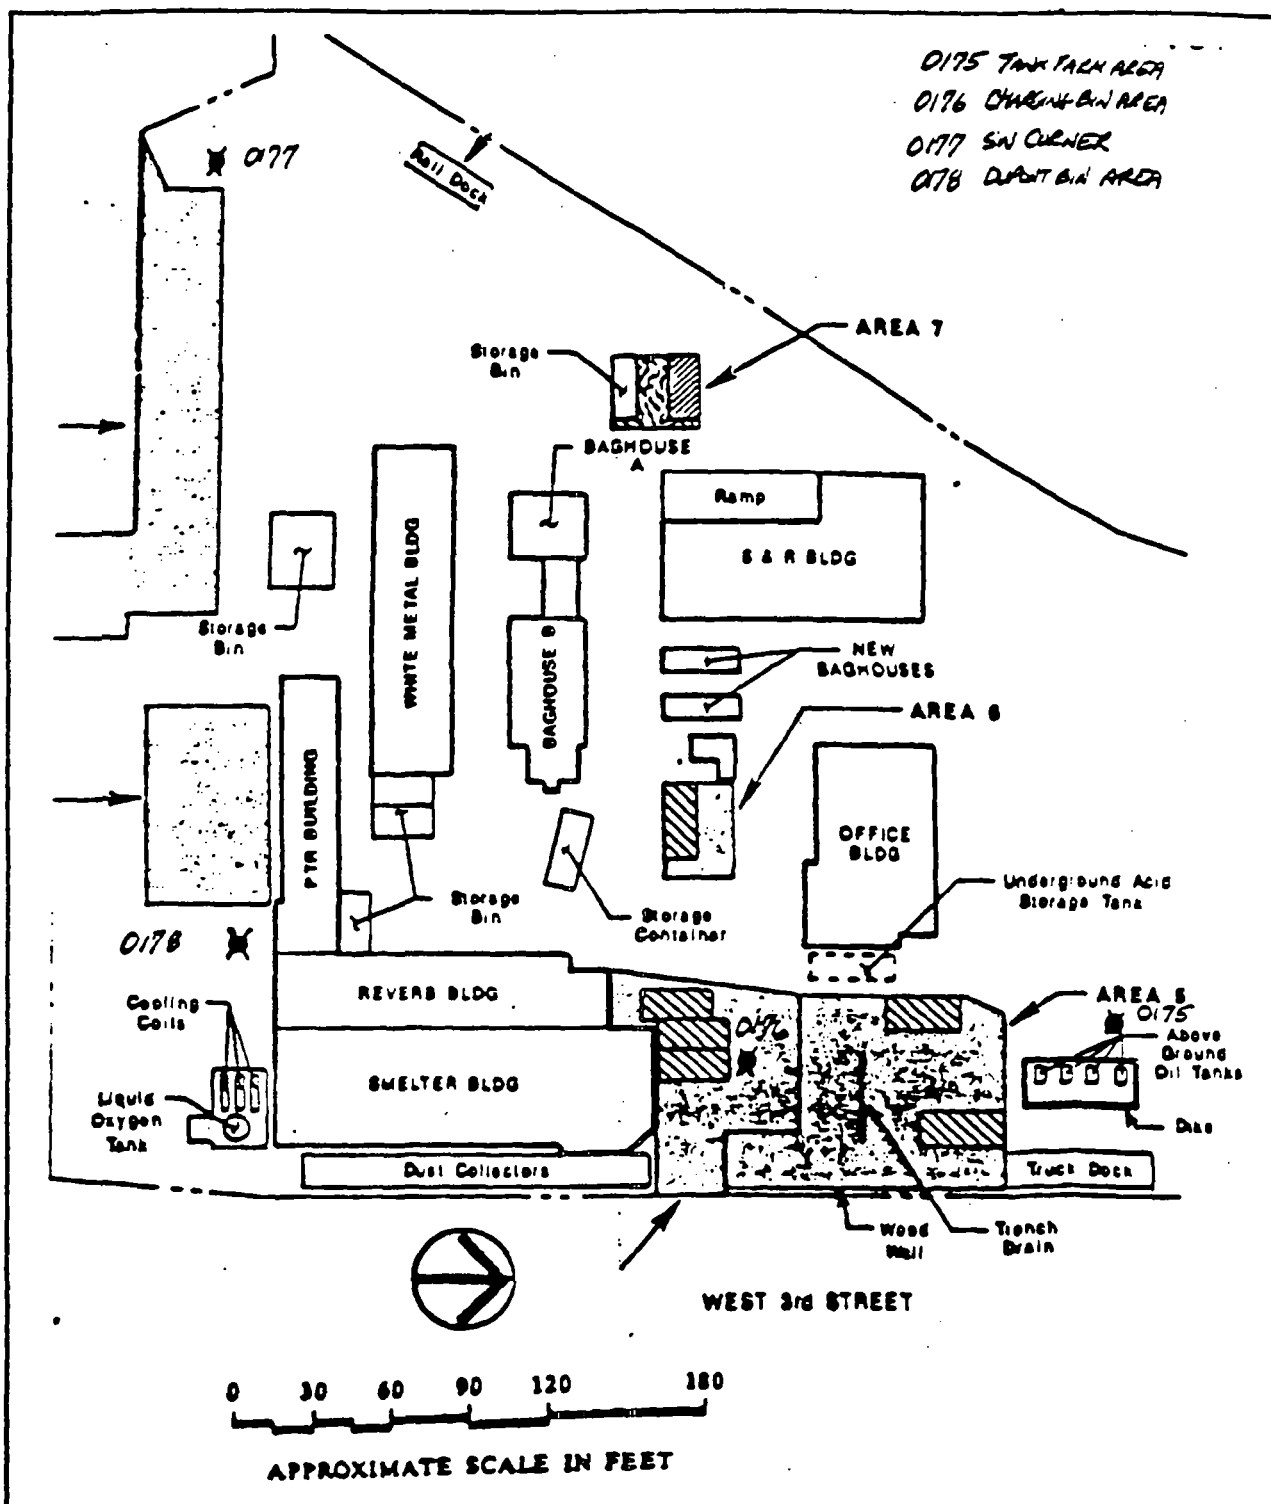
Figure 3
 Groundwater Monitoring Well Locations
 at the Master Metals, Inc., Facility
 in Cleveland, Ohio

Master Metals employed a consultant to install and sample four shallow groundwater monitoring wells at the facility in December 1990. The wells are located in or near former and present hazardous waste storage and handling areas (Figure 3). Groundwater samples from each of the four wells contained concentrations of lead and cadmium which exceed the Ohio maximum contaminant levels (MCL) for

inorganic chemicals in public drinking water supplies (Table 2). Two of the wells contained concentrations of chromium above the Ohio MCL. As of January 31, 1991, ESC had not received the consultant's draft report of the Phase II investigation or any relevant hydrogeological information. Without this information, it is not possible to determine if the analytical data is valid, if the source of the observed metals is onsite or is merely representative of background conditions, and the actual direction of groundwater flow. Few site-specific hydrogeologic data are available for the property. The location of the Cuyahoga River relative to the site (Figure 1) and the proximity of Lake Erie to Master Metals indicate that groundwater probably flows towards the northeastern direction below the property.

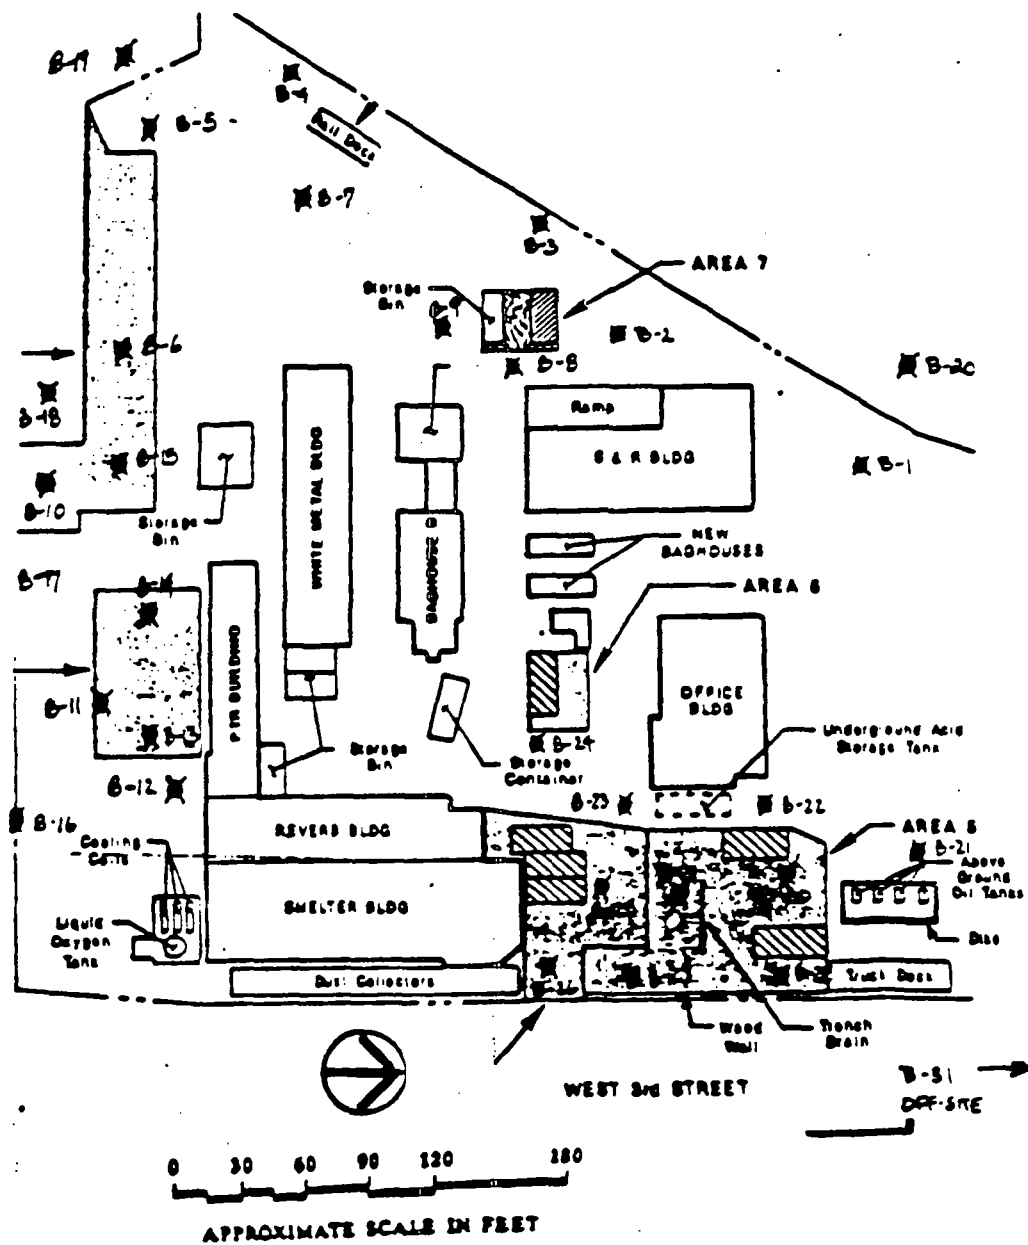
Figure 4
 December 1990 Soil Boring Locations at the
 Master Metals, Inc., Facility in
 Cleveland, Ohio

In December 1990, Master Metals employed a consultant to install and sample 30 soil borings underneath and near the property (Figure 4). ESC was provided with analytical results of the investigation (Appendix N). The samples were analyzed for pH and total metals concentrations. The result of the investigation indicate that soils beneath the southeastern corner of the property, the drum storage area, and the battery decasing area, as deep as 8 to 10 feet below grade, contain concentrations of lead exceeding 500 mg/kg. Some of the samples contained concentrations of lead exceeding 10,000 mg/kg. A sample collected at a depth of 3 to 5 feet near the southern perimeter of the property, B-10, contained 11,875 mg/kg of lead. Soil samples collected at offsite locations contained substantially lower concentrations of lead (14.7-229.0 mg/kg). The elevated levels of lead observed beneath the property may be attributable to historical onsite lead processing activities, and also may be a continuing source of lead contamination of groundwater. Other metals detected in soils beneath the site included cadmium (0.25-208.0 mg/kg), nickel (0.5-17.0 mg/kg), barium (0.5-88.0 mg/kg), and chromium (0.5-610.0 mg/kg). Soil samples collected in the vicinity of the battery cracking area at a depth of between 2 feet and 10 feet below grade were found to have a pH between 7.1 and 11.2. If any acidic liquids from battery cracking operations in this area have been released to soils beneath the concrete pad, these soils might be acidic and exhibit a low pH.
